Attachment A: Digital Images

April 29th, 2008

BOE Building 1st Floor Security Kiosk Area
Sacramento, CA

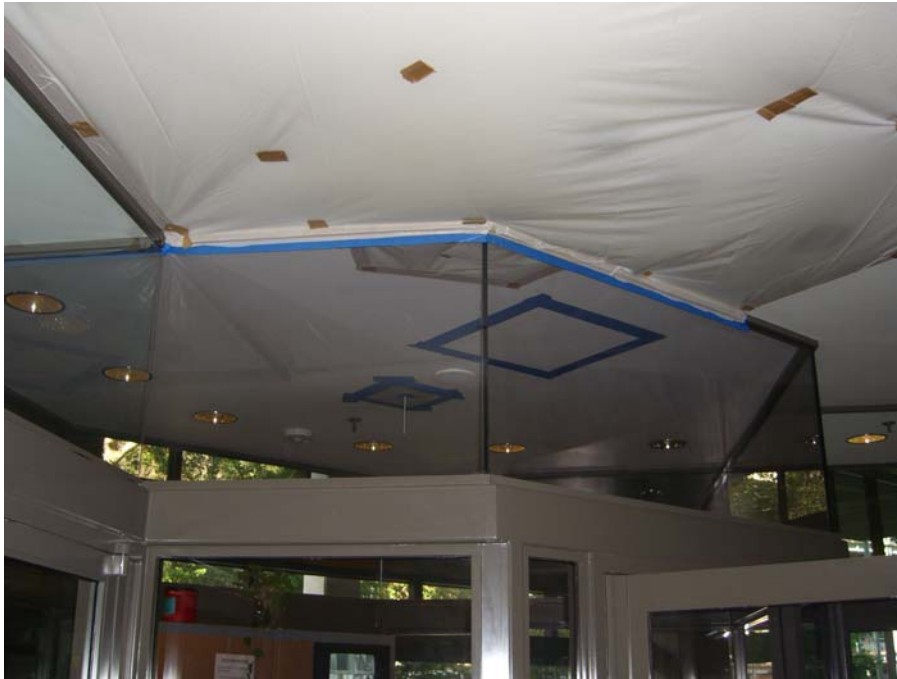
- 1) Image of security area kiosk station ceiling with interim containments in place at time of assessment of BOE Building (Subject Building) located at 450 N Street, Sacramento.

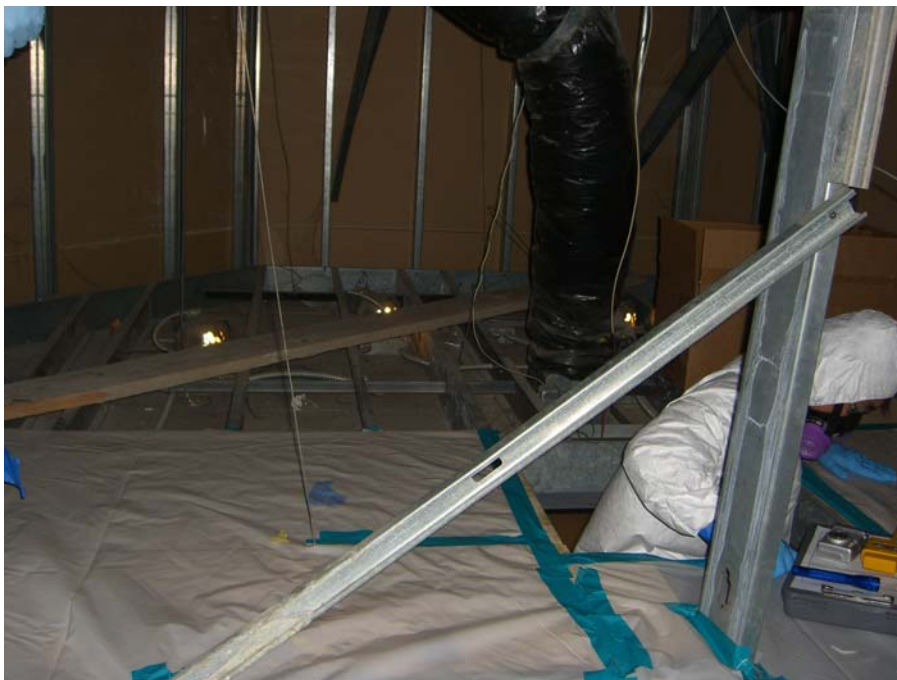
- 2) Image of inspector entering ceiling plenum space through access panel. Note presence of plastic containment barriers over impacted materials at time of inspection.

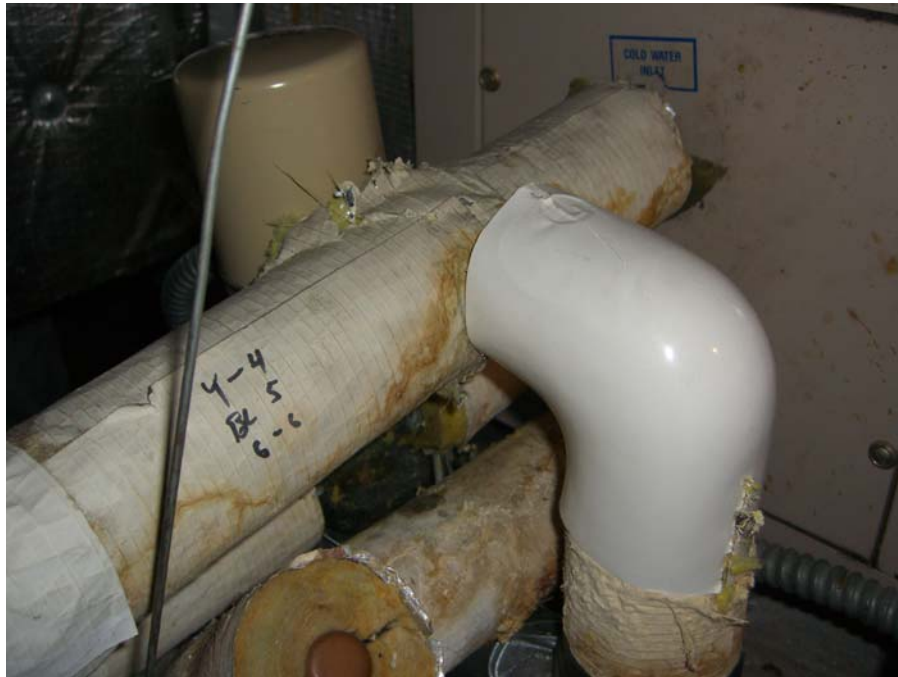
- 3) Image of HVAC plumbing with indications of moisture staining present on insulation materials located above the impacted areas.

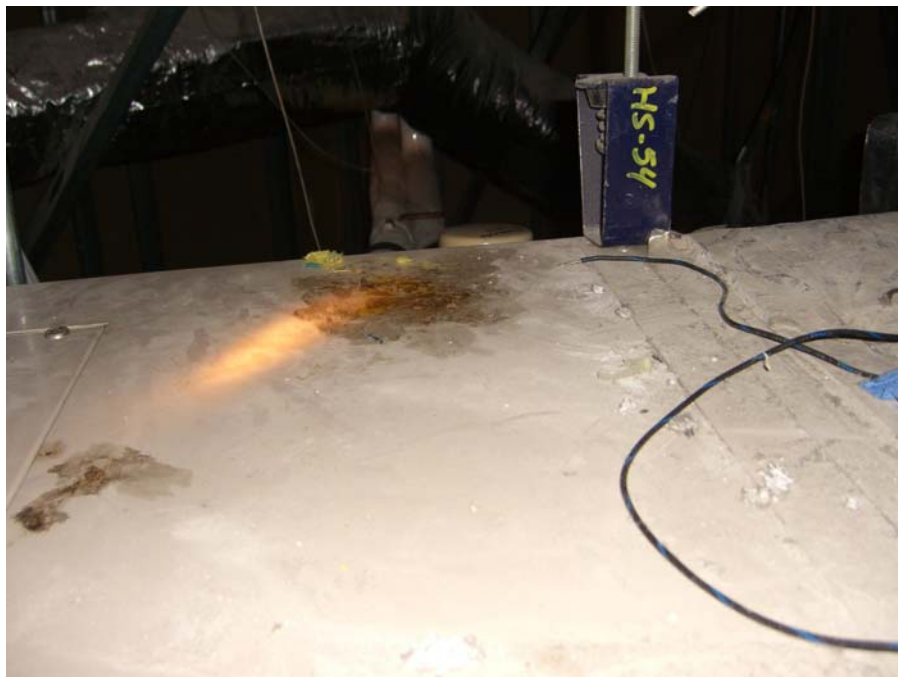
- 4) Image of stained sheetrock material associated with chronic moisture release from HVAC systems.

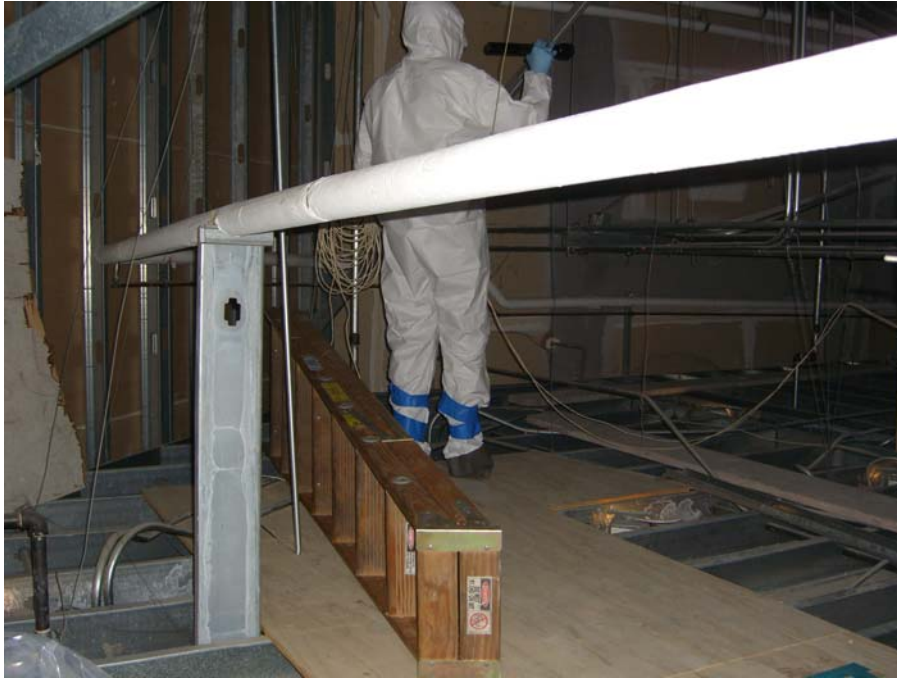
- 5) Image of inspector walking on plywood “cat walk” boards previously installed on ceiling joist structures within ceiling cavity.

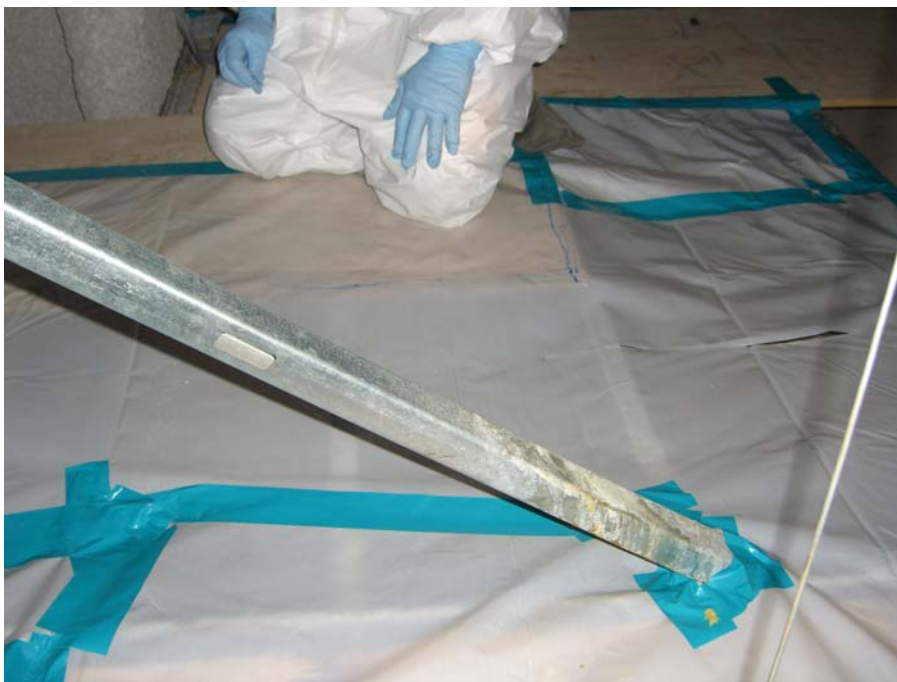
- 6) Additional image of plastic barriers which were opened to gain access for inspection and sampling of affected materials.

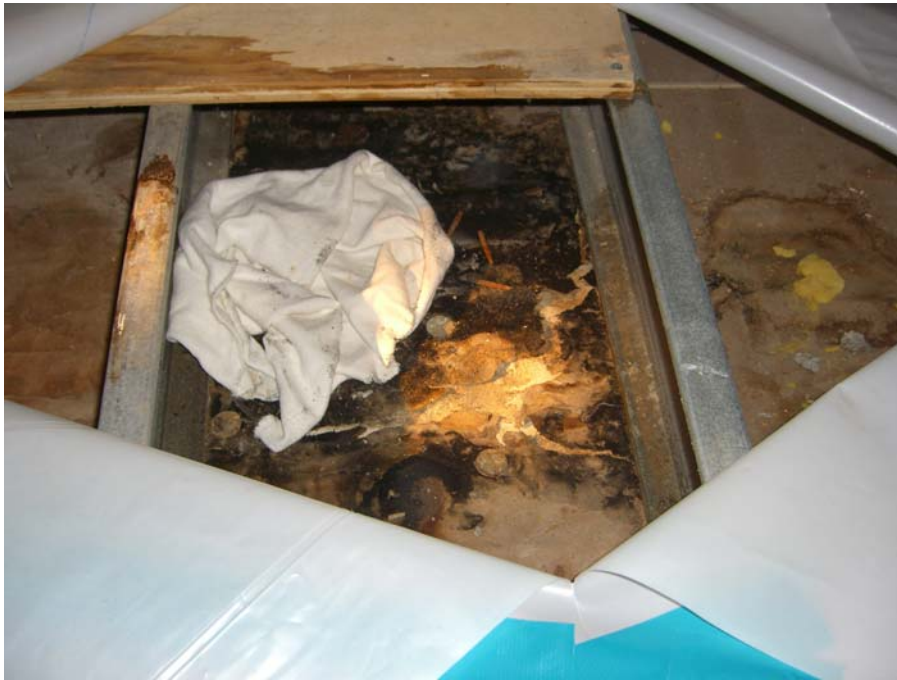
- 7) Close-up image of stained materials within ceiling materials of bay directly beneath HVAC system. Samples B01 and S01 collected from such materials.

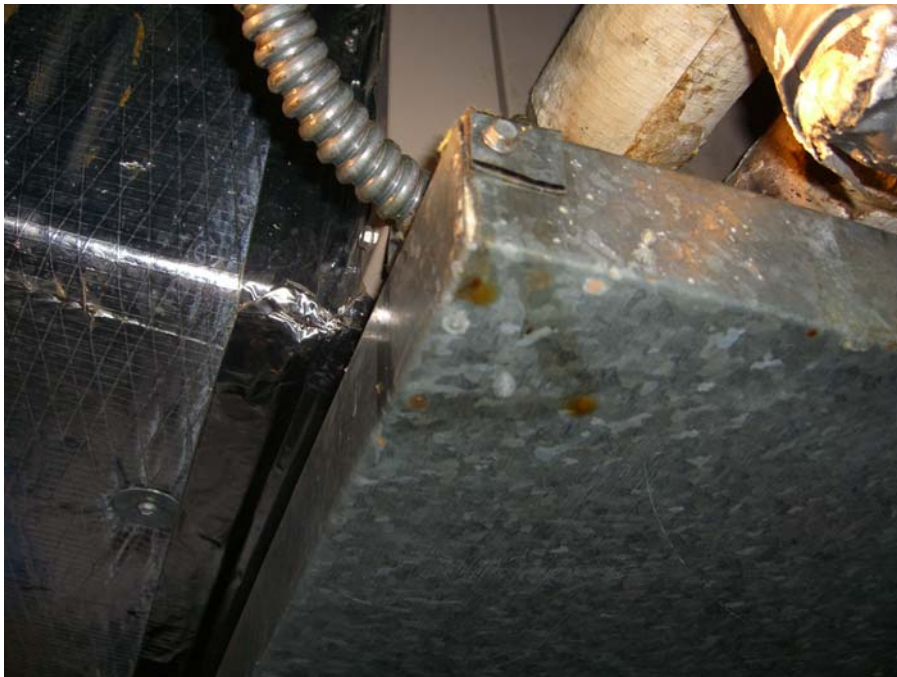
- 8) Image of physical dripping from corner of condensate pan located under HVAC system apparatus.

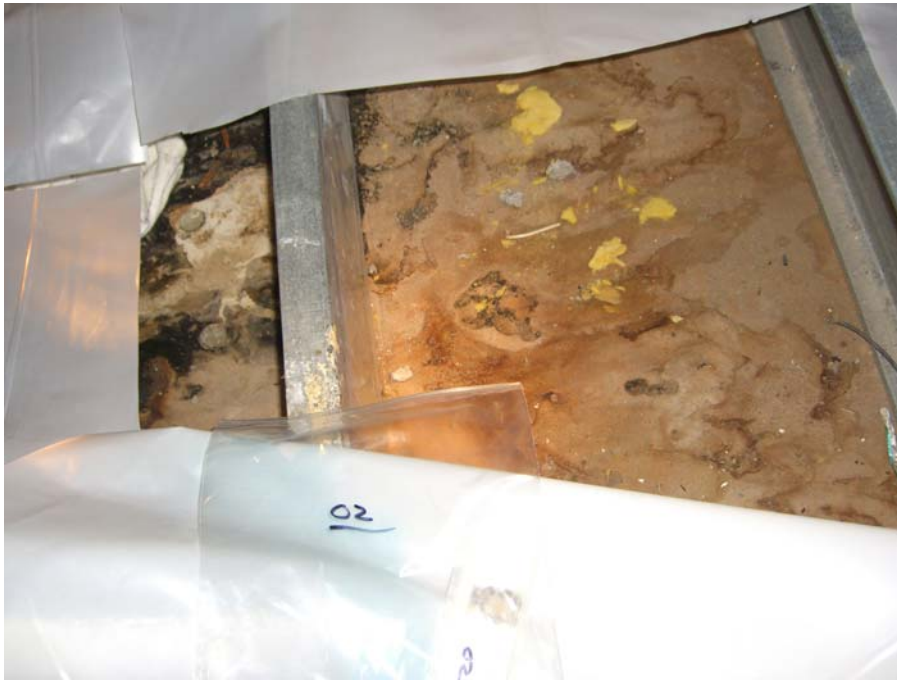
9) Image of adjacent bay cavity where Sample S02 was collected within impacted area.

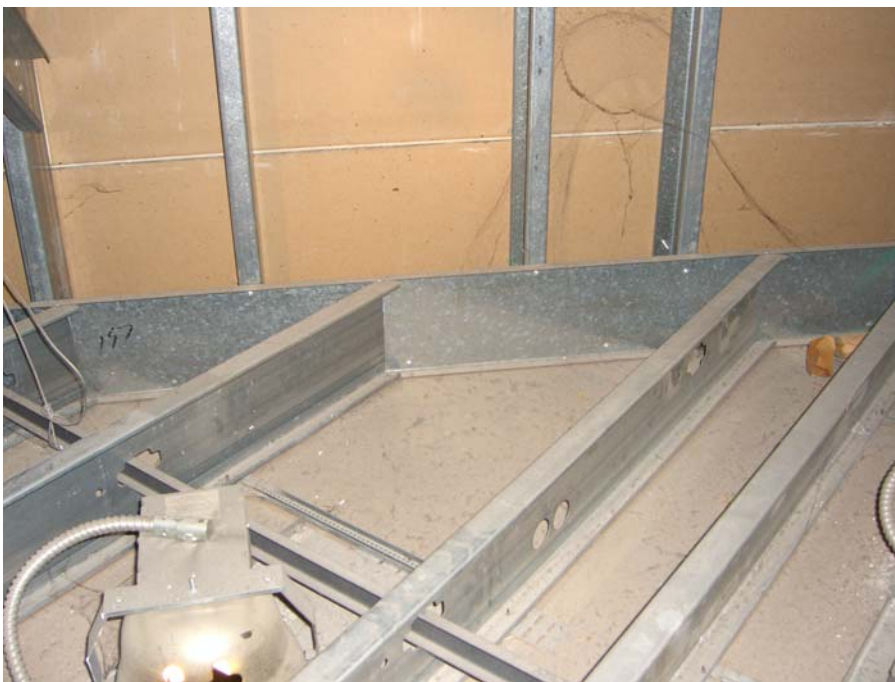
10) Image within ceiling plenum area away from impacted materials where surface control sample S06 was collected from horizontal surface in north corner of space.
